# Gorkha–Budhigandaki Flash Flood: Search, Rescue and Relief Response

## Situation Report #03

Date: 13 October 2026 (27 Asoj 2083), 10:00 PM

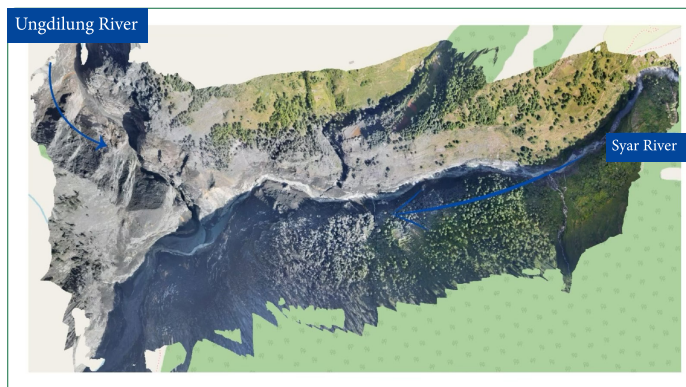
Satellite image 1. Upper Ungdilung Khola landslide area.

At approximately 04:20 on 11 October 2026 (25 Asoj 2083), a snow avalanche at about 6,000 m elevation and a major landslide involving glacier ice and debris at approximately 5,500 m occurred in the upper reaches of Ungdilung Khola, Chumnubri Rural Municipality–6, between Chamar Himal and Syerang Himal. The area contains relatively weak rocks of the Tibetan Tethys Himalaya.

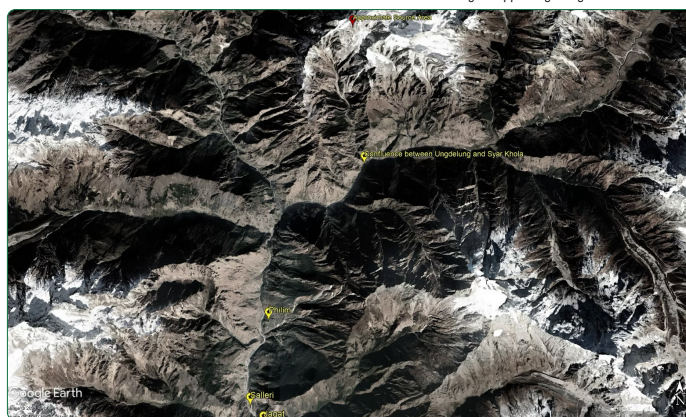
Satellite image 2. Landslide and debris-flow corridor.

Smaller landslides were observed both before and after the principal failure. The mixed flow of snow, water and debris traveled south down the steep Ungdilung valley, rising as much as 300 m along the valley sides. At about 2,000 m elevation, large quantities of debris accumulated at the narrow confluence of Ungdilung and Syar Khola, repeatedly blocking and releasing the water flow. Similar temporary blockage may also have occurred at the Syar Khola–Budhigandaki confluence. These processes produced multiple flood surges downstream.

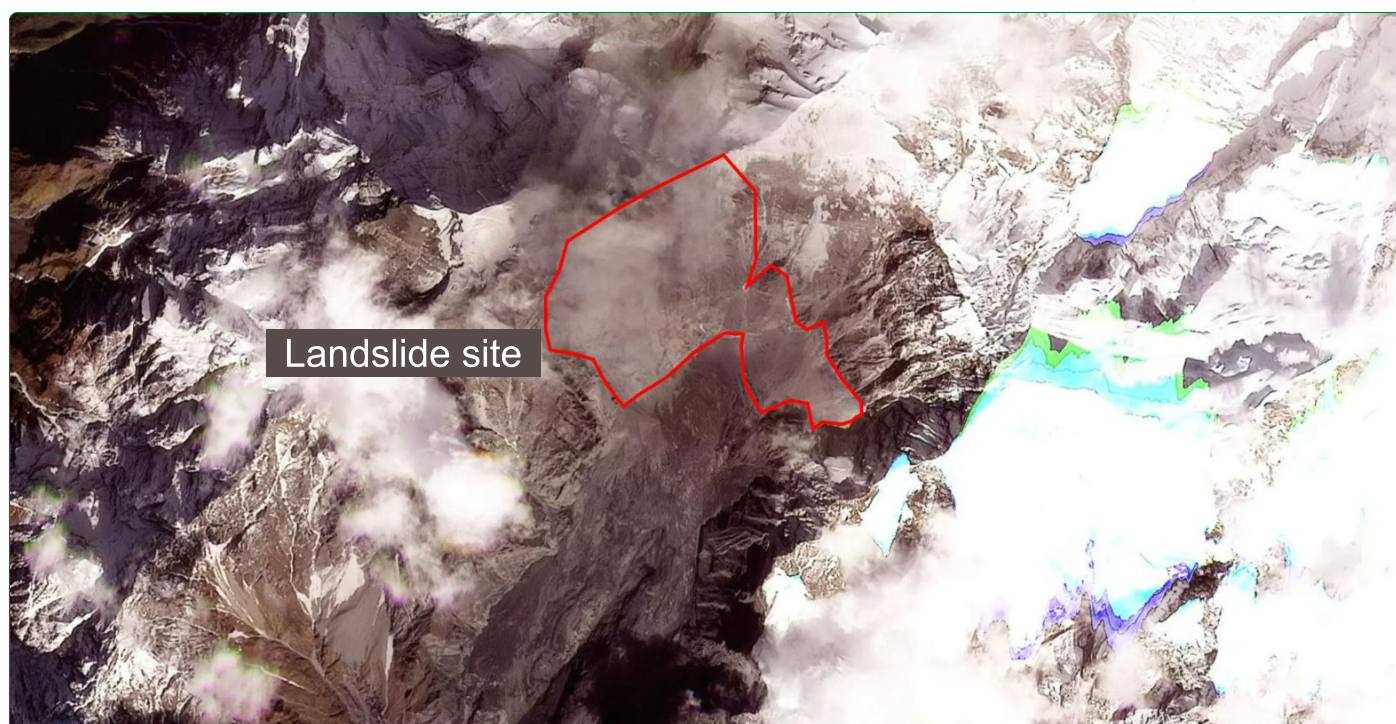
Satellite map. Landslide site (translation of original Nepali map label).
